Thermowell, Thermocouple, RTD

Monju sodium leak and fire

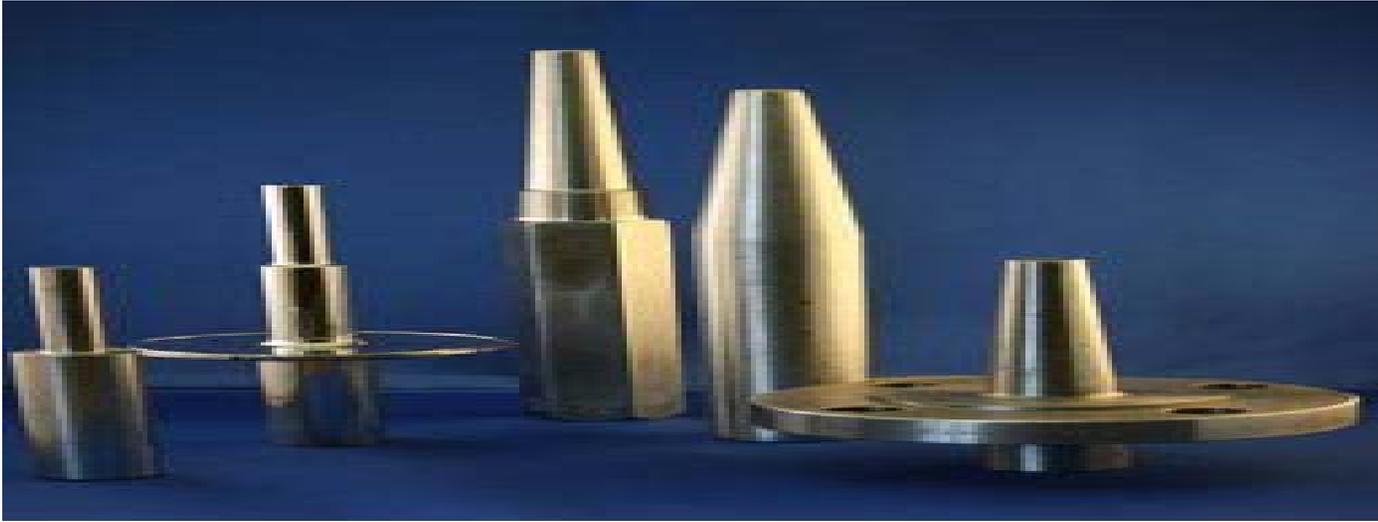
- The thermowell may seem a fairly simple piece of equipment, designed to act as a barrier between temperature sensor and the process medium.
- Yet it is fundamental to the safety of the process; a faulty thermowell can jeopardize the whole operation.
- The main risk comes from vortices forming in the process medium around the thermowell, which can cause vibrations. The stresses caused around the stem of the thermowell by these vibrations can, over time, lead to failure.
- Incorrectly specifying pressure-retaining parts can have disastrous consequences, in the worst cases potentially leading to loss of life, loss of the plant and possible

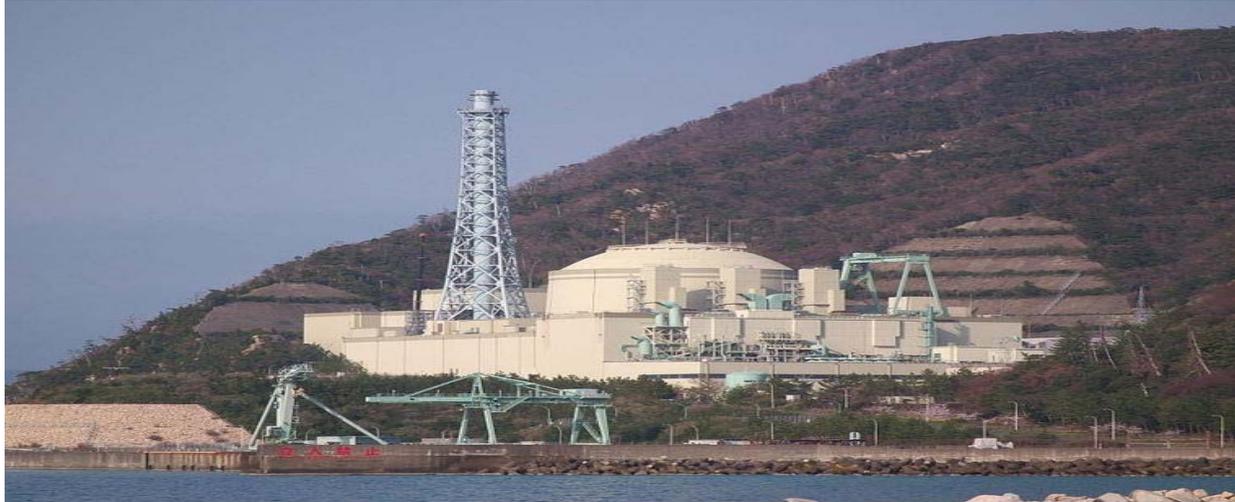
An accident in December 1995, in which a sodium leak caused a major fire, forced a shutdown of a Nuclear Power Plant (MONJU) in Japan

- the reactor suffered a serious accident. Intense vibration caused a [thermowell](#) inside a pipe carrying sodium coolant to break, allowing several hundred kilograms of sodium to leak out onto the floor below the pipe.
- Upon contact with air, the liquid sodium reacted with oxygen and moisture in the air, filling the room with caustic fumes and producing temperatures of several hundred [degrees Celsius](#).

Root Cause of Failure of Thermowell

- Design Standard ASME PTC19.3, 1974
 - Failed to address in-line vibration,
 - Failed to assess oscillatory stress independent of steady state bending stresses.
 - Provided no fatigue factor for oscillatory stress or stress intensification factor for fatigue at the thermowell root, and Performed the installed natural frequency calculation in a very crude manner.
- After approximately five years of work, in July 2010, the ASME PTC 19.3TW (2010) standard was published and received ANSI approval

- Most significant factor impacting thermowell design is the recognition of the need to avoid in-line resonance in most cases—the factor identified as the root cause of the MONJU failure.
